# Lake Havasu City Wash Management Plan

# **Executive Summary**

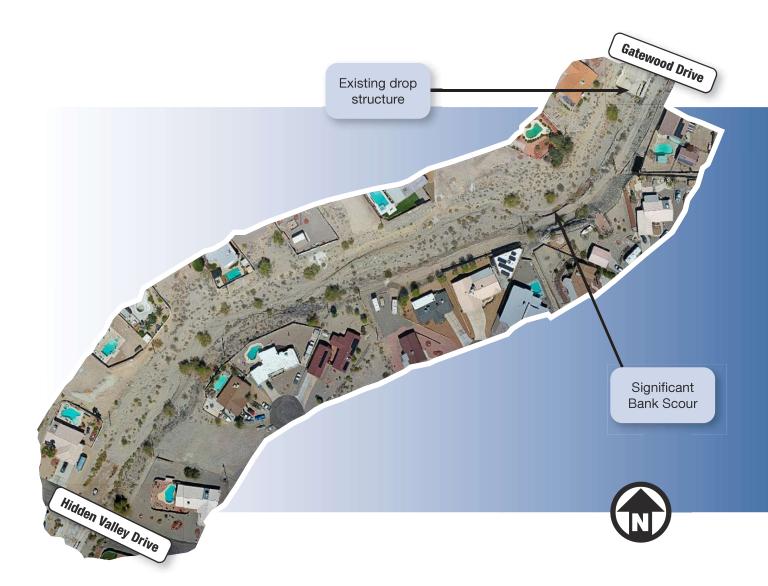
### **Smoke Tree Wash 3**

Smoketree Wash 3 is located between Gatewood Drive and Hidden Valley Drive. The reach has moderate meandering and shows evidence of significant scour along the banks approximately 250 feet south of Gatewood Drive. There are also several other spot locations where the meandering reach has become very concise. Utility poles are located along the tops of the banks.

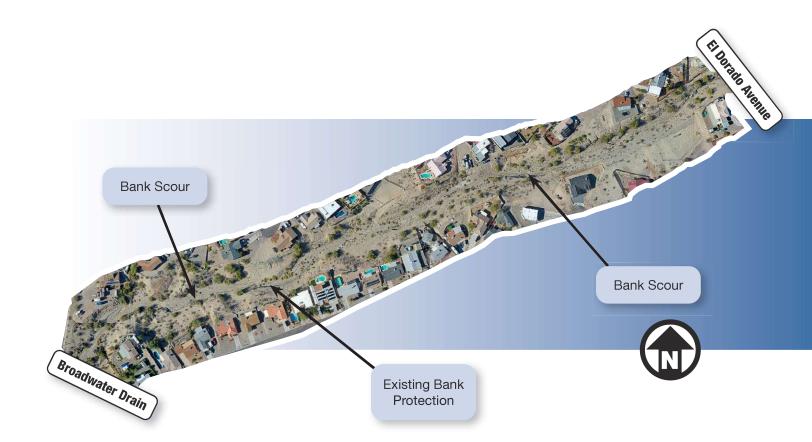
### Pima Wash 8

Pima Wash 8 is located between El Dorado Avenue and the confluence with Broadwater Drain. The reach has moderate meanders and shows evidence of bank scour at several locations throughout the reach. Gabion bank protection was installed along the southern bank approximately 1,500 feet downstream of El Dorado Avenue. This reach was identified in the previous top 10 reaches.

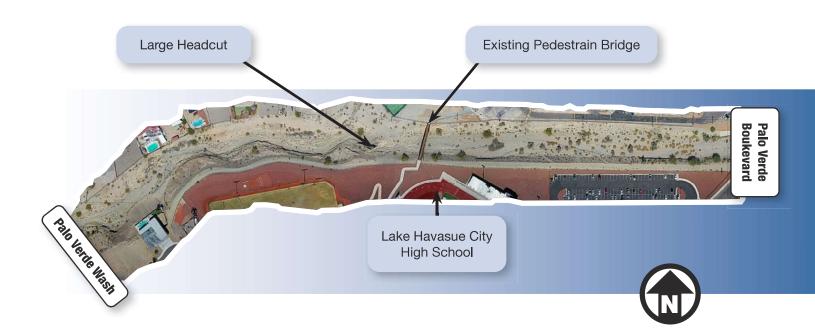
### El Dorado 6

El Dorado 6 is located between Palo Verde Boulevard and the confluence with Palo Verde Wash. The wash is located along the athletic fields for Lake Havasu City high school. The reach is split by a pedestrian bridge spanning the wash. The eastern portion of the wash is straight, steeper and less depth. A large headcut is located 125 feet downstream of the pedestrian bridge. The wash has significant meandering and evidence of scour downstream of the headcut.

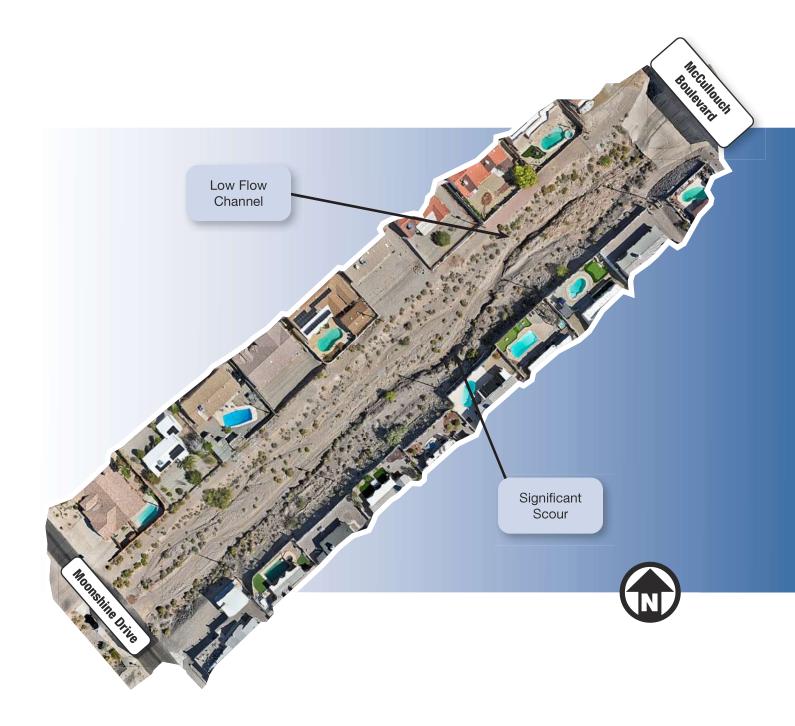
### **Indian Peak Wash 16**

Indian Peak Wash 16 is located between McCulloch Boulevard and Moonshine Drive. The overall reach is straight but shows evidence of significant scour along the banks. A low flow channel has carved out significant scour in the middle of wash. Utility poles are located along the banks of the reach.

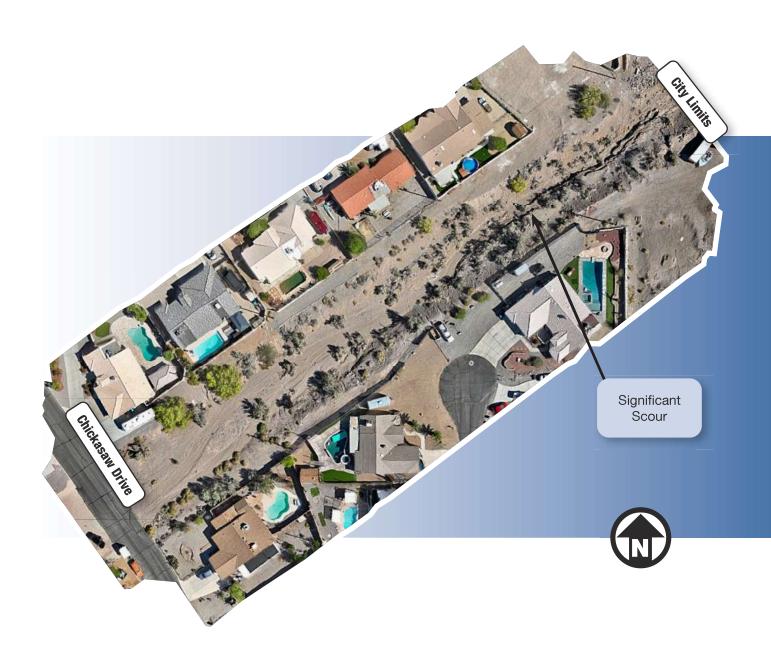
### **Chemehuevi Wash 13**

Chemehuevi Wash 13 is located between the eastern boundary of the City limits and Chickasaw Drive. The overall reach is straight with significant scour along the southern banks. Utility poles are located along the top of the banks.

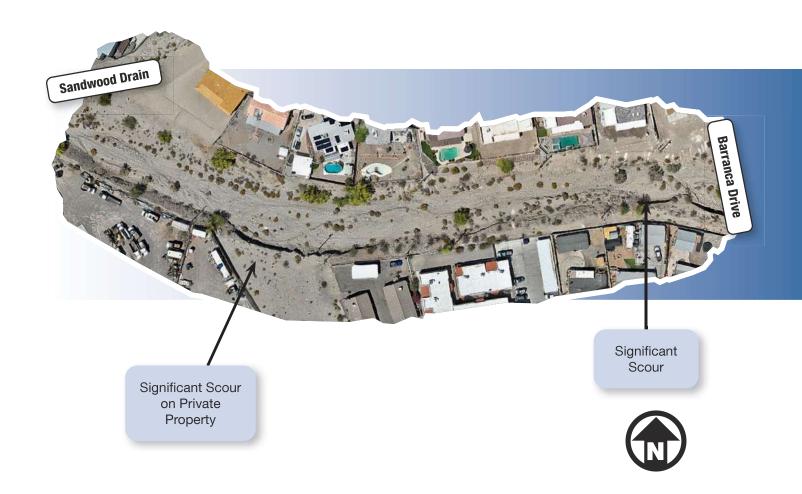
### **Kiowa Drain 6**

Kiowa Drain 6 is located between Barranca Drive and the confluence with Sandwood Drain. The reach has a mild meander with evidence of significant bank scour along the south banks. Private property is at risk of further damage as a result of the bank scour.

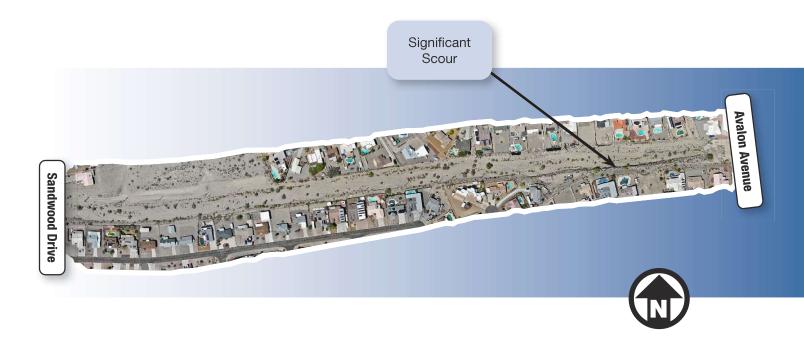
## **Havasupai Wash 7**

Havasupai Wash 7 is located between Avalon Avenue and Sandwood Drive. The reach is mostly straight but has significant scour along the southern banks in the upstream portion of the reach. Utility poles are located along the top of the banks throughout the reach.

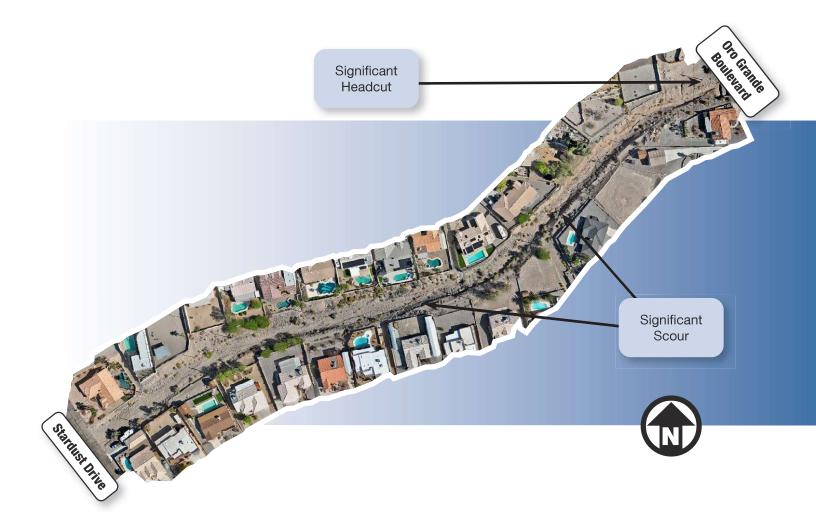
### **Buena Vista Wash 2**

Buena Vista 2 is located between Oro Grande Boulevard and Stardust Drive. The reach has moderate meandering. Significant scour is evident along the southern bank. A significant headcut is evident at the upstream drop structure at the beginning of the reach. Utility poles are located along the tops of the banks.

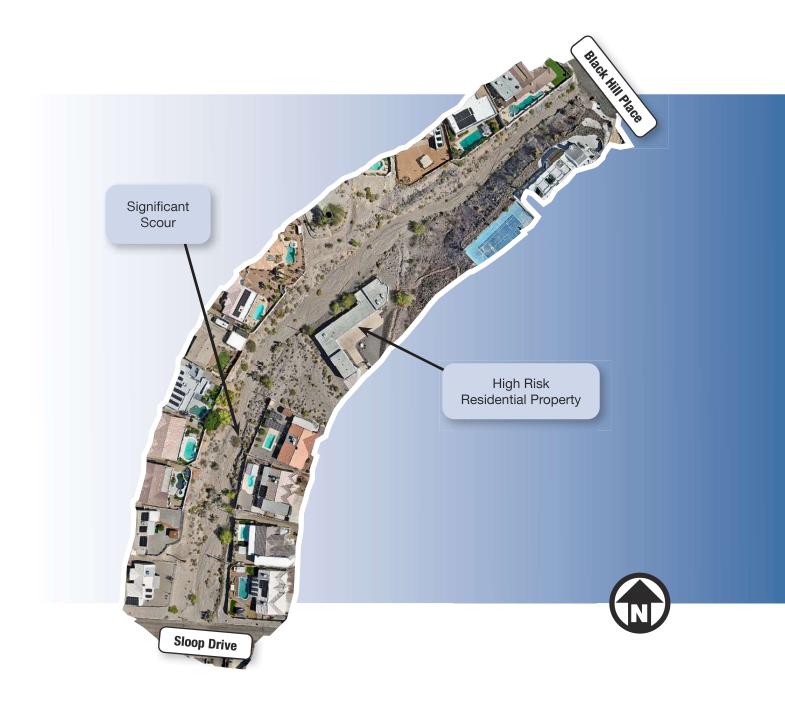
### **Indian Peak 18**

Indian Peak Wash 18 is between Black Hill Place and Sloop Drive. Residential structures are very close to the existing water surface elevation and high velocities. Significant low flow scour has created a meandering, concise channel at the bottom of the wash. Utility poles are located along the top of banks

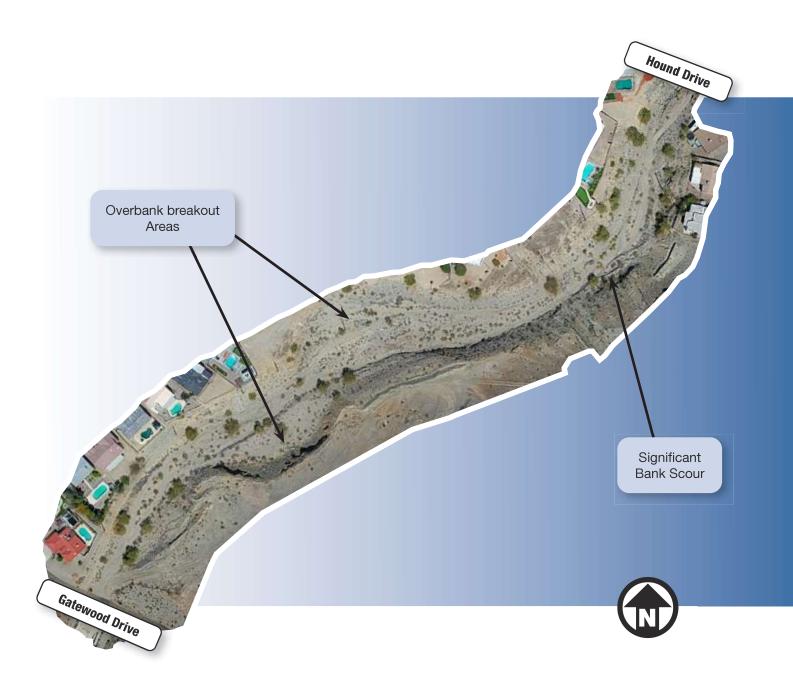
### **Smoketree Wash 4**

Smoketree Wash 4 is between Hound Drive and Gatewood Drive. The reach has significant meandering with evidence of significant bank scour at multiple locations. There are also large areas of overbank where the wash has meandered on to private property.

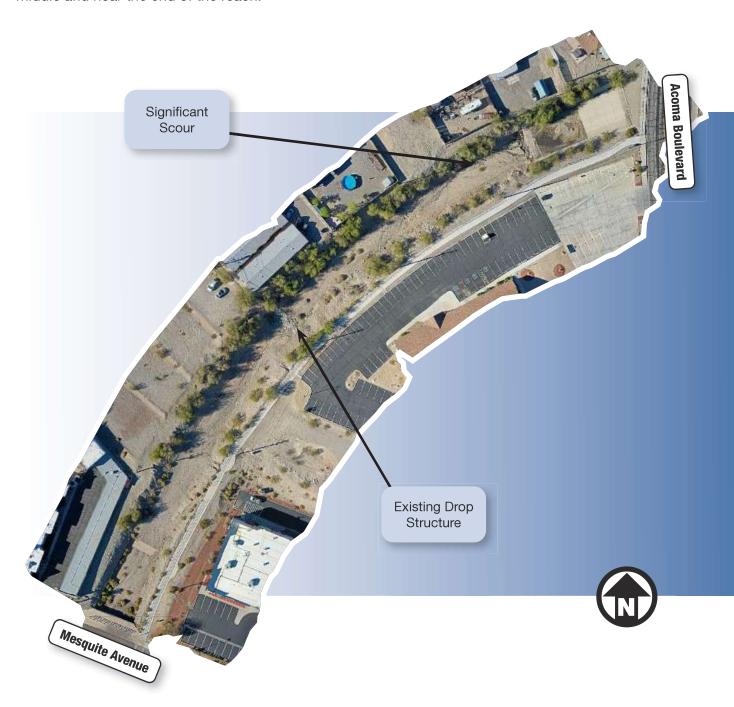
### Pima Wash 6

Pima Wash 6 is located between Acoma Boulevard and Mesquite Avenue. The reach has mild meandering but evidence of scour at multiple locations along the banks. An existing drop structure is located in the middle and near the end of the reach.
