# Lake Havasu City **Wash Management Plan**

Adopted by Resolution No. 25-3878  
City Council October 28, 2025

# Executive Summary

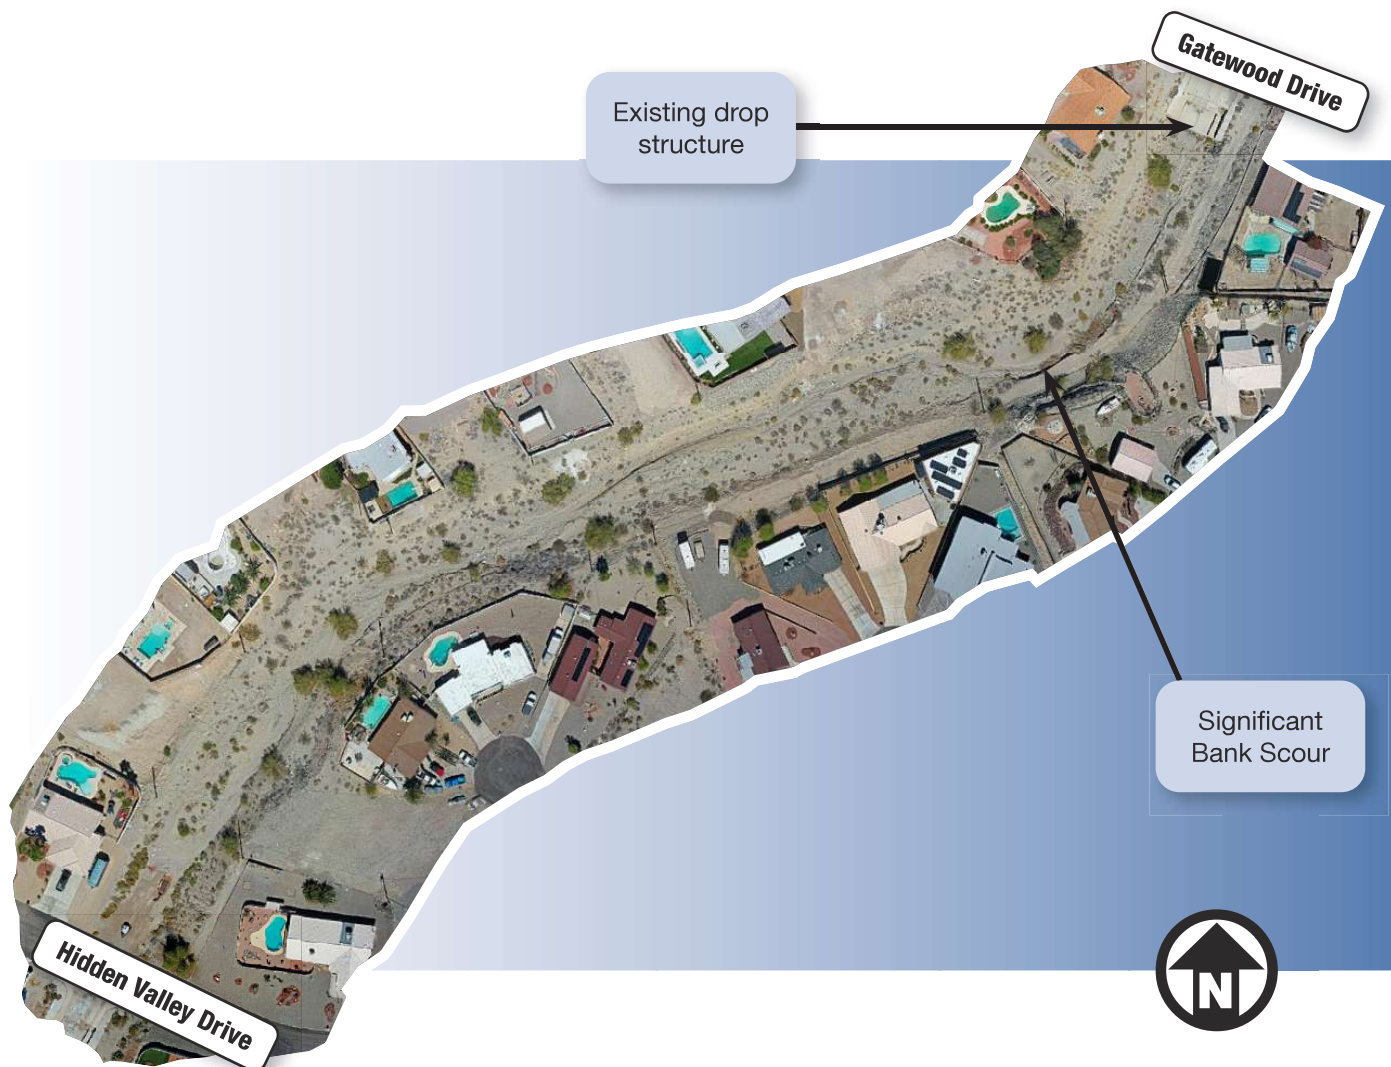
### Smoke Tree Wash 3

Smoketree Wash 3 is located between Gatewood Drive and Hidden Valley Drive. The reach has moderate meandering and shows evidence of significant scour along the banks approximately 250 feet south of Gatewood Drive. There are also several other spot locations where the meandering reach has become very concise. Utility poles are located along the tops of the banks.

| Wash | Alternative 1 | Alternative 2 |
|---|---|---|
| Smoketree Wash 3 | Drop Structures | Bank Protection Only |

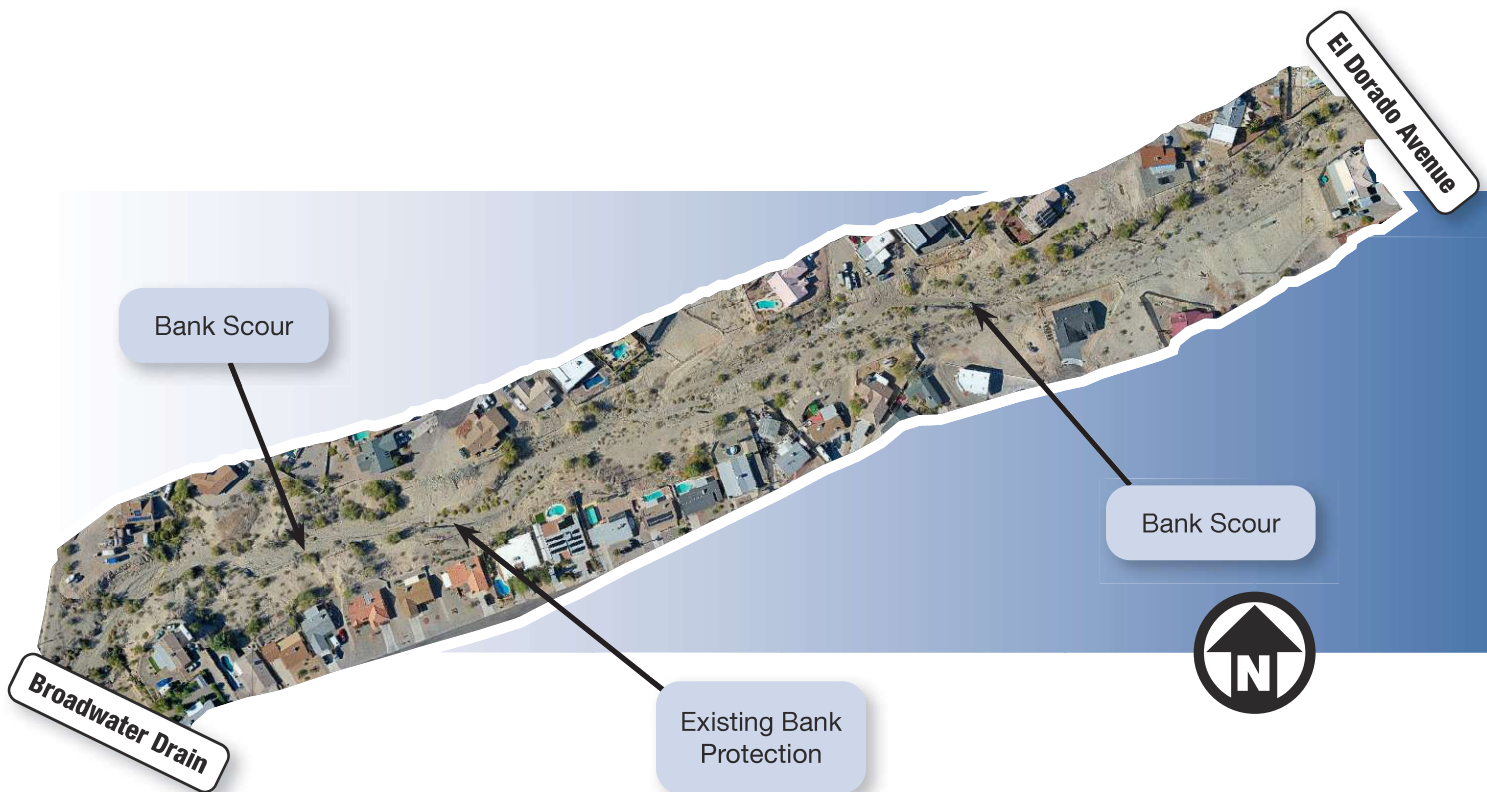
## Pima Wash 8

Pima Wash 8 is located between El Dorado Avenue and the confluence with Broadwater Drain. The reach has moderate meanders and shows evidence of bank scour at several locations throughout the reach. Gabion bank protection was installed along the southern bank approximately 1,500 feet downstream of El Dorado Avenue. This reach was identified in the previous top 10 reaches.

| Wash | Alternative 1 | Alternative 2 |
|---|---|---|
| Pima Wash 8 | Drop Structures | Full Channel Protection |

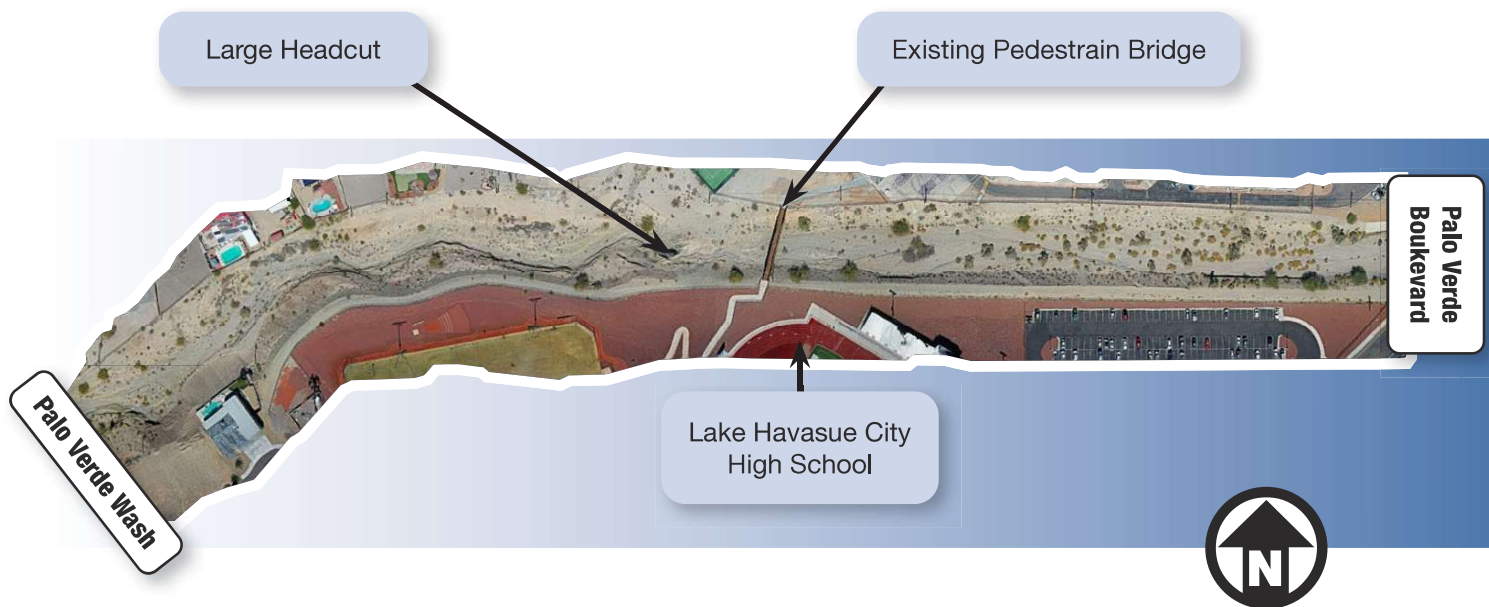
## El Dorado 6

El Dorado 6 is located between Palo Verde Boulevard and the confluence with Palo Verde Wash. The wash is located along the athletic fields for Lake Havasu City high school. The reach is split by a pedestrian bridge spanning the wash. The eastern portion of the wash is straight, steeper and less depth. A large headcut is located 125 feet downstream of the pedestrian bridge. The wash has significant meandering and evidence of scour downstream of the headcut.

| Wash | Alternative 1 | Alternative 2 |
|---|---|---|
| El Dorado Wash 6 | Full Channel Protection | Drop Structures |

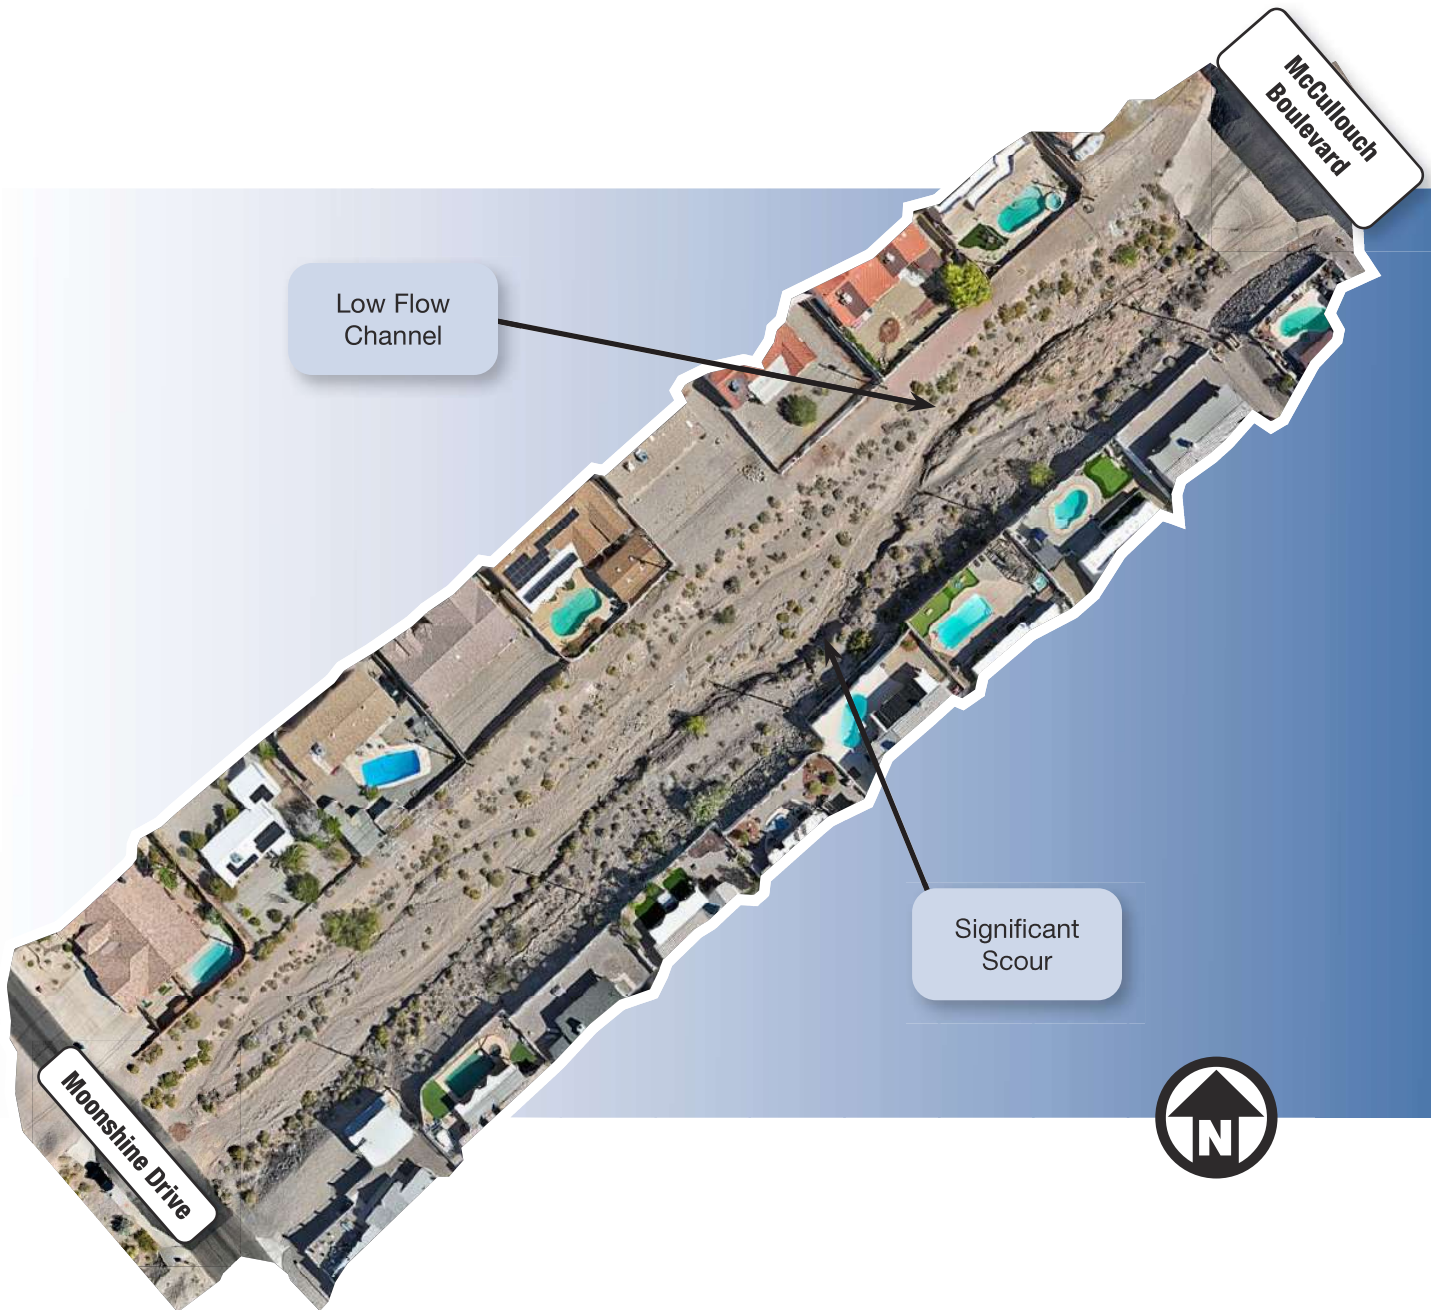
## Indian Peak Wash 16

Indian Peak Wash 16 is located between McCulloch Boulevard and Moonshine Drive. The overall reach is straight but shows evidence of significant scour along the banks. A low flow channel has carved out significant scour in the middle of wash. Utility poles are located along the banks of the reach.

| Wash | Alternative 1 | Alternative 2 |
|---|---|---|
| Indian Peak Wash 16 | Bank Protection Only | Full Channel Protection |

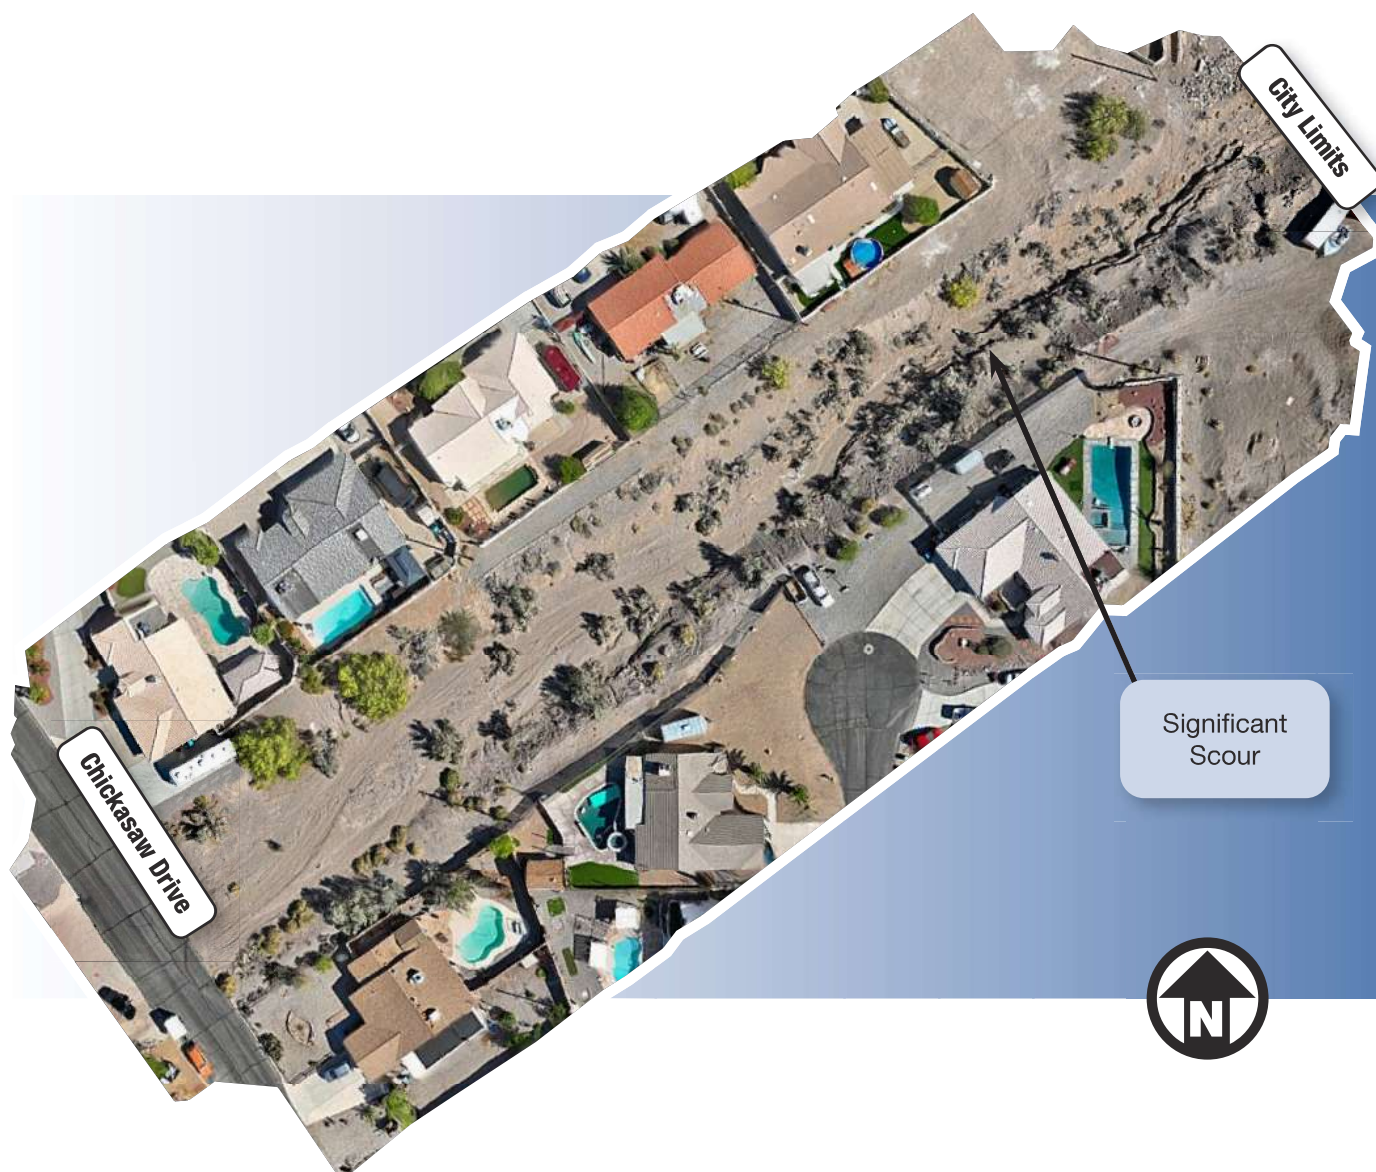
## Chemehuevi Wash 13

Chemehuevi Wash 13 is located between the eastern boundary of the City limits and Chickasaw Drive. The overall reach is straight with significant scour along the southern banks. Utility poles are located along the top of the banks.

| Wash | Alternative 1 | Alternative 2 |
|---|---|---|
| Chemehuevi Wash 13 | Drop Structures | Full Channel Protection |

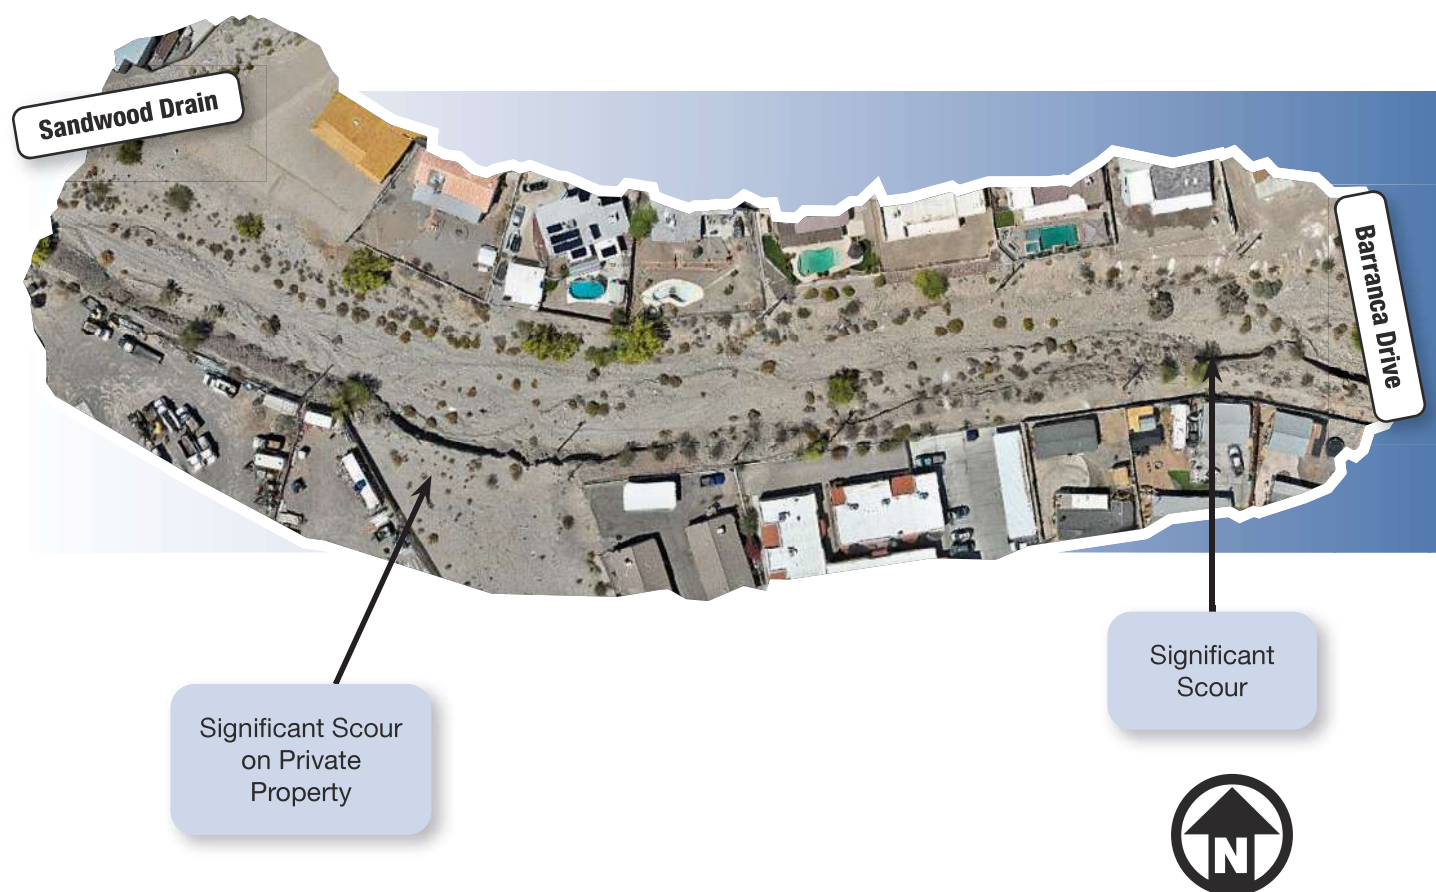
## Kiowa Drain 6

Kiowa Drain 6 is located between Barranca Drive and the confluence with Sandwood Drain. The reach has a mild meander with evidence of significant bank scour along the south banks. Private property is at risk of further damage as a result of the bank scour.

| Wash | Alternative 1 | Alternative 2 |
|---|---|---|
| Kiowa Drain 6 | Drop Structures | Bank Protection Only |

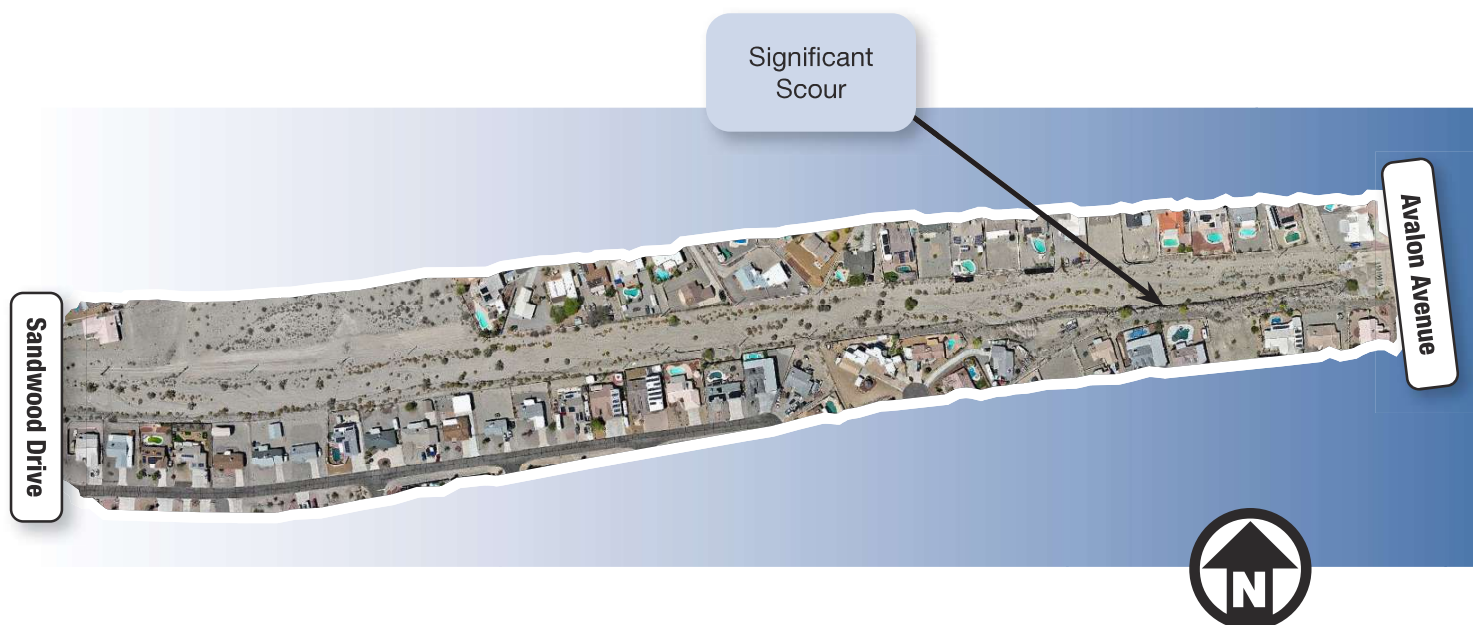
## Havasupai Wash 7

Havasupai Wash 7 is located between Avalon Avenue and Sandwood Drive. The reach is mostly straight but has significant scour along the southern banks in the upstream portion of the reach. Utility poles are located along the top of the banks throughout the reach.

| Wash | Alternative 1 | Alternative 2 |
|---|---|---|
| Havasupai Wash 7 | Bank Protection Only | |

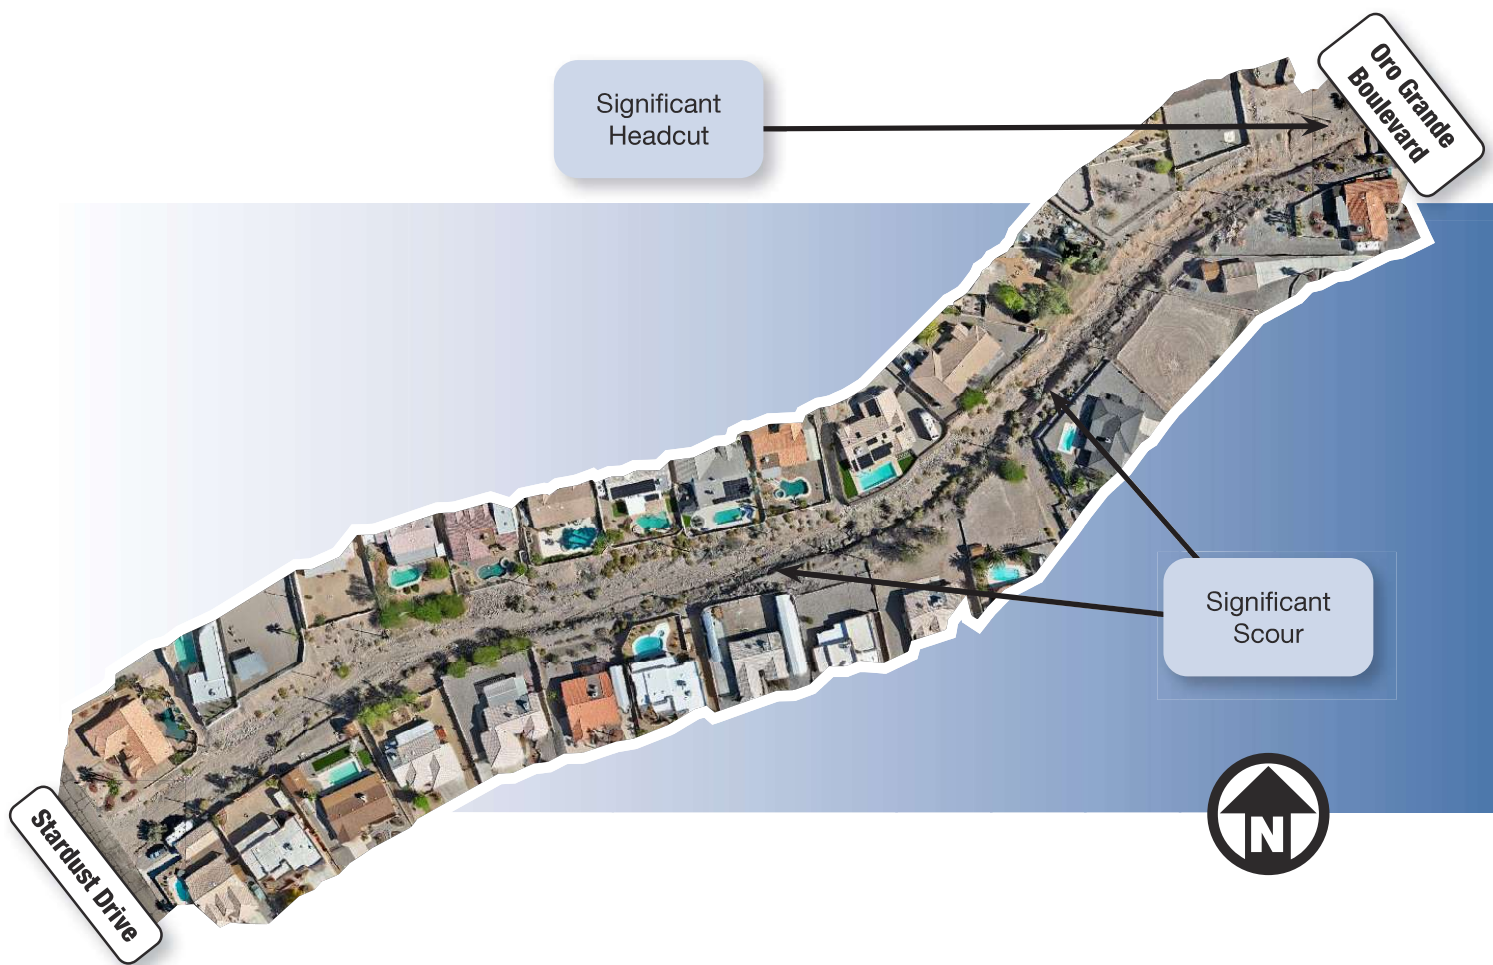
## Buena Vista Wash 2

Buena Vista 2 is located between Oro Grande Boulevard and Stardust Drive. The reach has moderate meandering. Significant scour is evident along the southern bank. A significant headcut is evident at the upstream drop structure at the beginning of the reach. Utility poles are located along the tops of the banks.

| Wash | Alternative 1 | Alternative 2 |
|---|---|---|
| Buena Vista 2 | Full Channel Protection | |

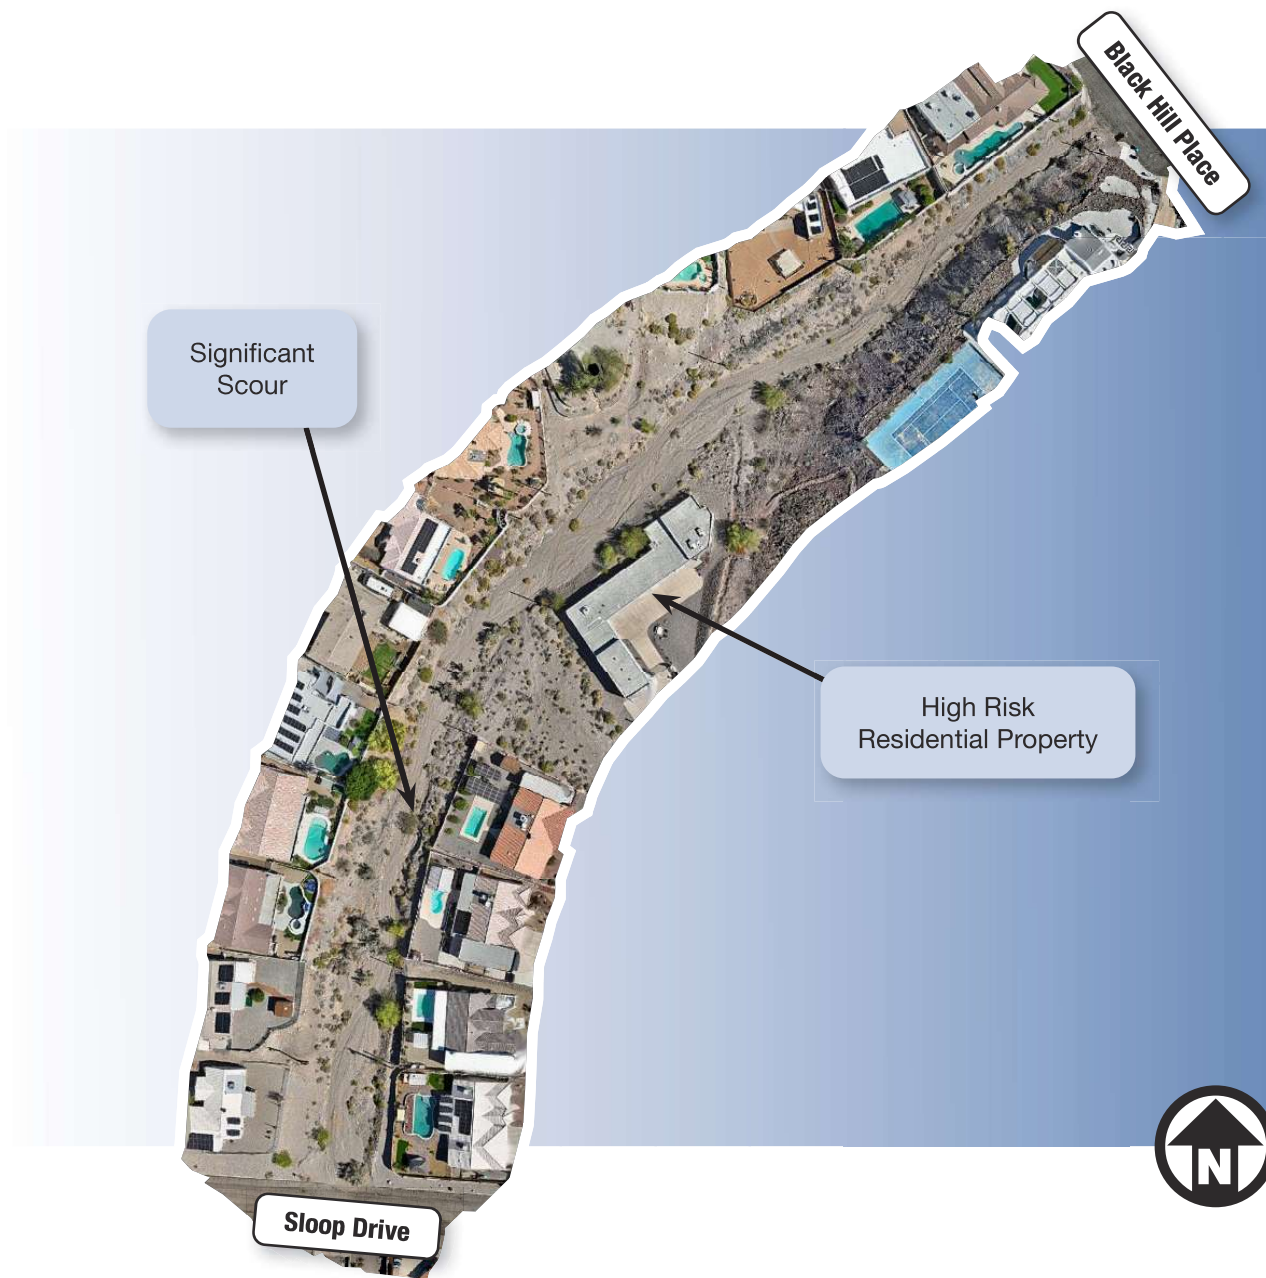
## Indian Peak 18

Indian Peak Wash 18 is between Black Hill Place and Sloop Drive. Residential structures are very close to the existing water surface elevation and high velocities. Significant low flow scour has created a meandering, concise channel at the bottom of the wash. Utility poles are located along the top of banks

| Wash | Alternative 1 | Alternative 2 |
|---|---|---|
| Indian Peak Wash 18 | Full Channel Protection | |

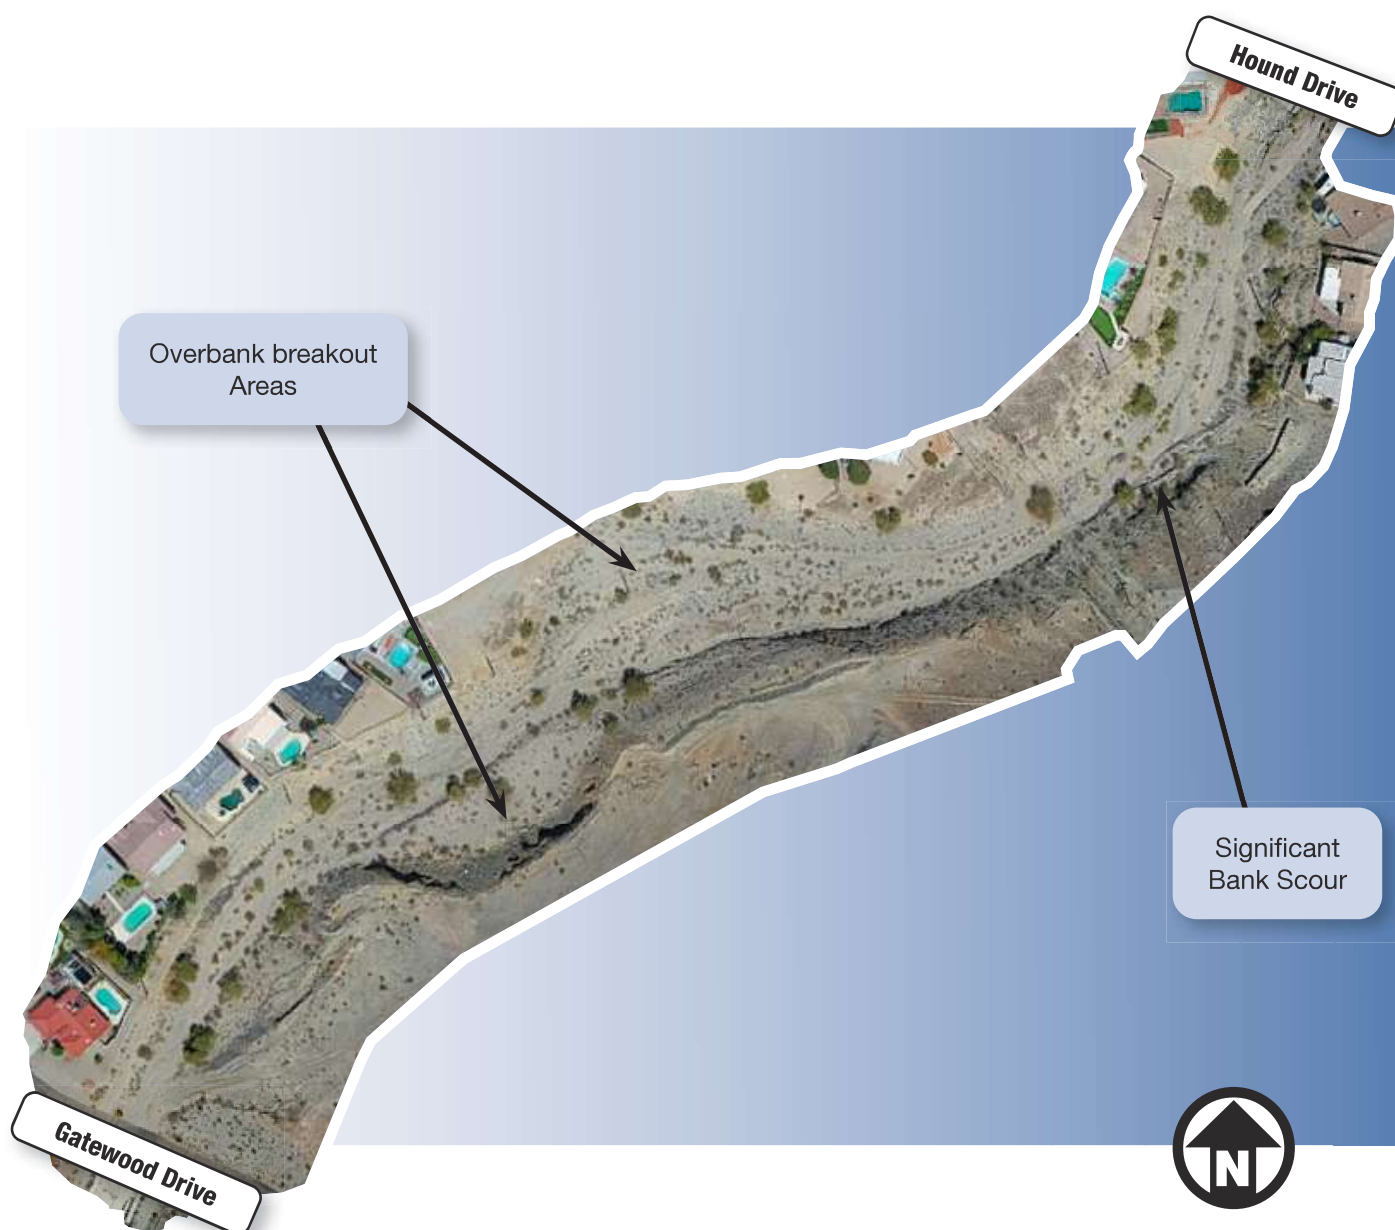
## Smoketree Wash 4

Smoketree Wash 4 is between Hound Drive and Gatewood Drive. The reach has significant meandering with evidence of significant bank scour at multiple locations. There are also large areas of overbank where the wash has meandered on to private property.

| Wash | Alternative 1 | Alternative 2 |
|---|---|---|
| Smoketree Wash 4 | Drop Structures | Bank Protection Only |

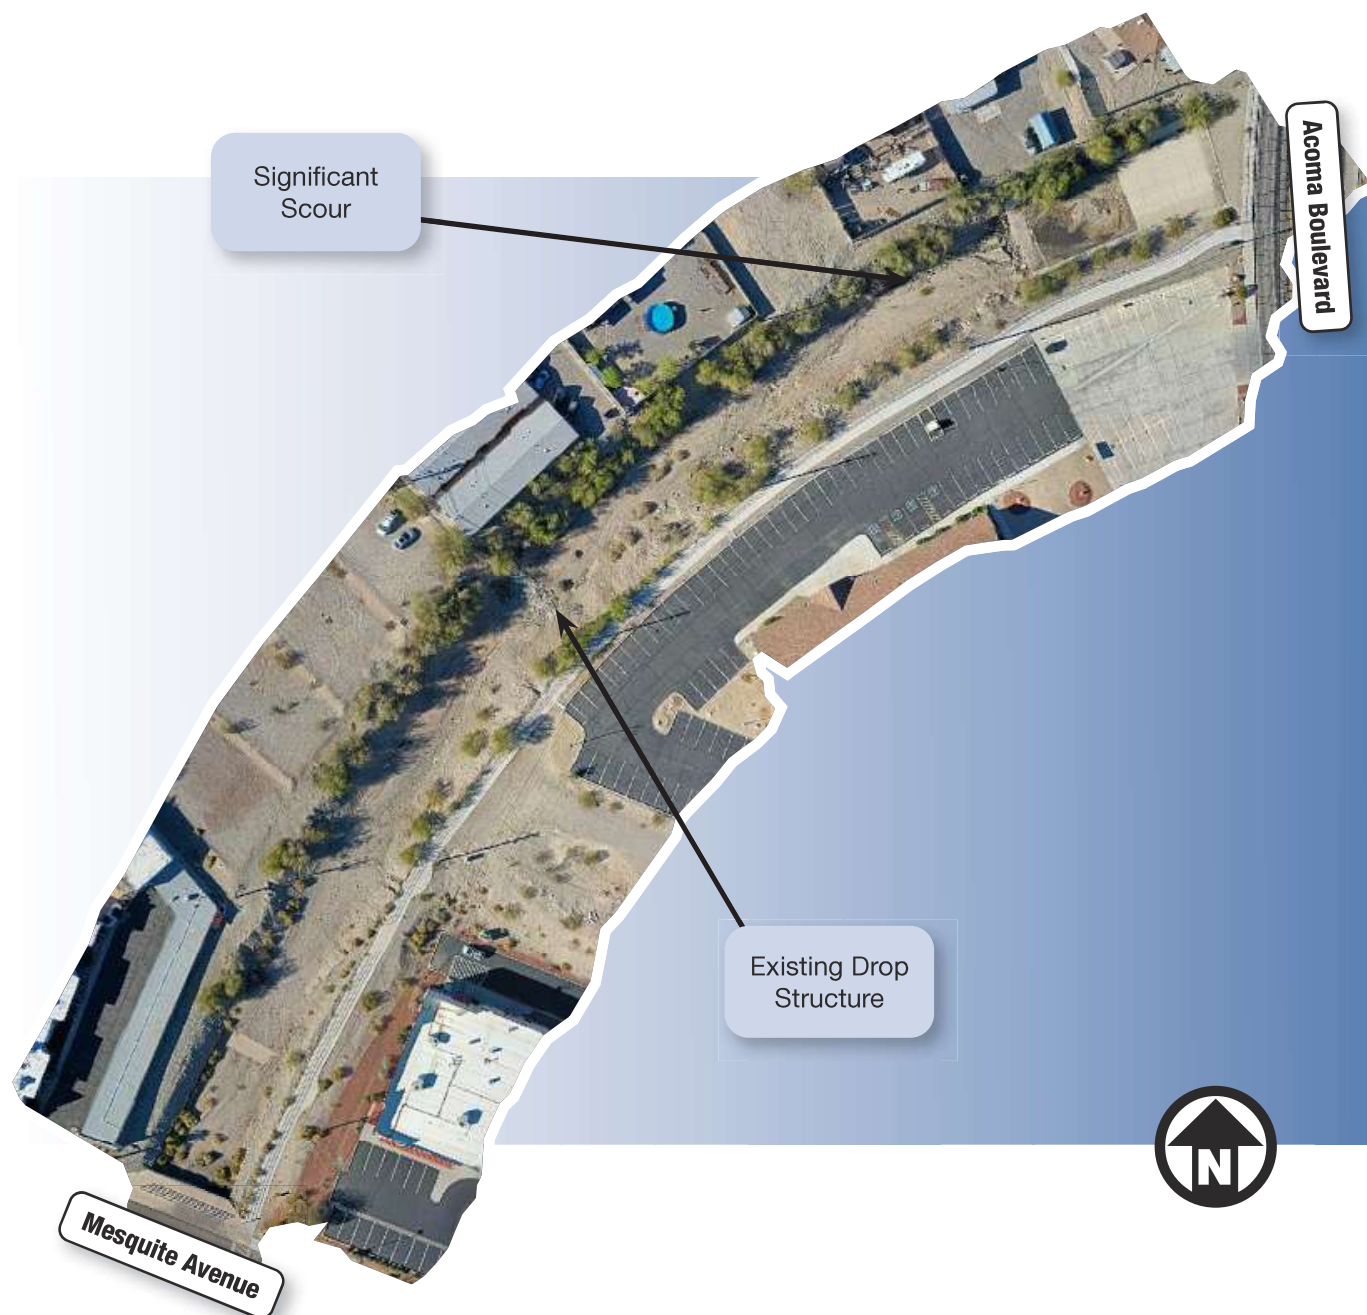
## Pima Wash 6

Pima Wash 6 is located between Acoma Boulevard and Mesquite Avenue. The reach has mild meandering but evidence of scour at multiple locations along the banks. An existing drop structure is located in the middle and near the end of the reach.

| Wash | Alternative 1 | Alternative 2 |
|---|---|---|
| Pima Wash 6 | Drop Structures | Bank Protection Only |
